Thorne Bay  
Unit 8-1 (Southern half of unit only)  
15 September 1978

Unit  
8-1  
179.8 Ac.

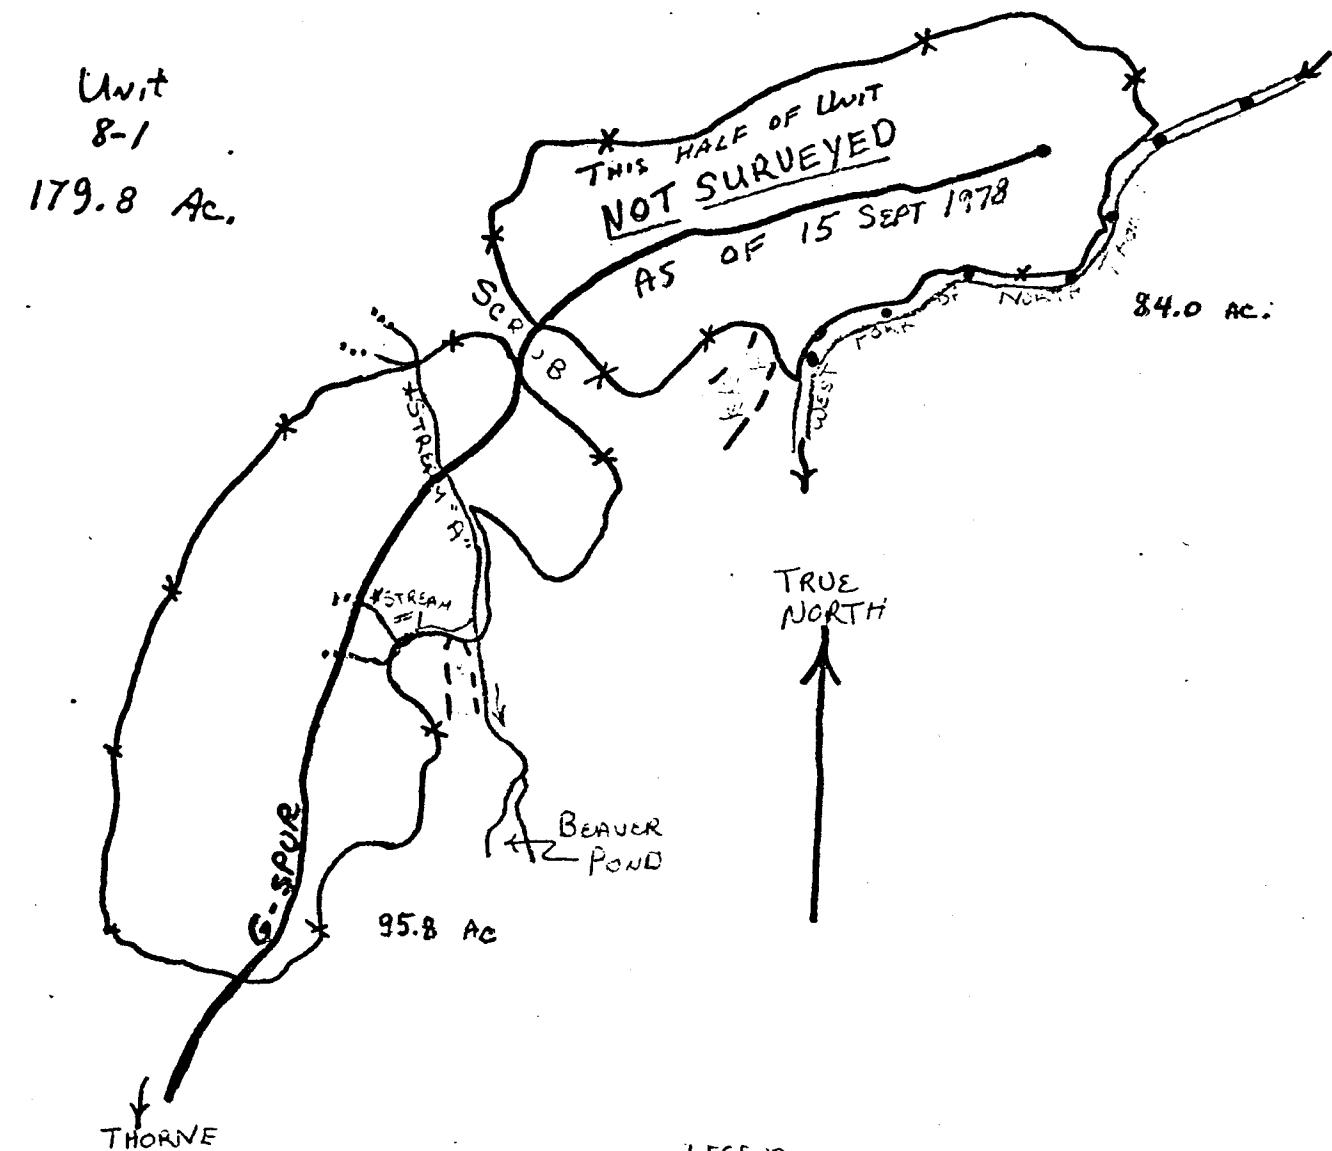
Stream #A is main body of stream system. Streams 1, 2, 3, 4, & 5 are all tributaries to stream A. Stream is 8 to 12 feet wide and 2 to 3 feet deep with pools of 3 to 5 feet deep. Gravel and rock substrate with a gradient of less than 5%.

Excellent Coho rearing habitat up to debris barrier indicated on map with probable Coho spawning habitat in this area. Above debris barrier was excellent resident fish habitat. 3 Dolly Varden & 1 Cutthroat were shocked above road while 9 Dolly Varden were trapped above debris barrier and below road. 3 Coho were shocked below the debris jam while 1 Dolly Varden and 1 Cutthroat were trapped below the debris barrier.

Stream #1 Stream is 3 feet wide and 4 to 6 in. deep with a sand & gravel substrat providing excellent habitat. The stream meanders parallel to the unit boundary and below it. Streams #1A and #1B are tributaries to Stream #1. The stream flows into the unit for approximately 400 ft. until it joins the main Stream A.

2 Coho, 1 Dolly Varden, and 1 Cutthroat were shocked below the unit boundary. 4 Coho were shocked within the unit. Excellent Coho rearing habitat within unit and beneath the unit until a 4 ft. falls presents a barrier. All Coho habitat was tagged and flagged blue and white.

Coho, Dolly Varden, and Cutthroat were all shocked in this oxbow. Very heavy slash and fallen logs present a barrier to Coho fry. The "G" spur culvert is not fish passing! Tagged and flagged Blue & White from lower joint with Stream #A to barrier presented a

Tagged and flagged Blue & White from lower unit boundary to the debris barrier. Flagged Orange & White from debris barrier to upper unit boundary. Large scale debris, slash, and fallen log cleanup project should be implemented as quickly as possible. Some action should be taken to access any damage incurred by stream banks due to

Note: Recommend slash and debris cleanup for the 400 ft. of flagged habitat within the unit, just below where stream #1B intersects Stream #1, as soon as possible.

3 Coho of 3½ to 4 in. were shocked within the unit. A great deal of slash and fallen logs in stream. Tagged and flagged Blue & White from where it joins Stream #A to the 6 ft. barrier falls below "G" spur. Recommend major slash and log cleanup as soon as possible.

Recommend major cleanup of slash and fallen logs in streambed as soon as possible.  
(Refer to map for further detail.)
